**Flood Control Project Maintenance
Levee Inspections**
LMA District Cover Sheet
Spring 2018 Levee Inspection Results

Reclamation District No. 0349 Sutter Island

Spring 2018 Levee Inspection Results

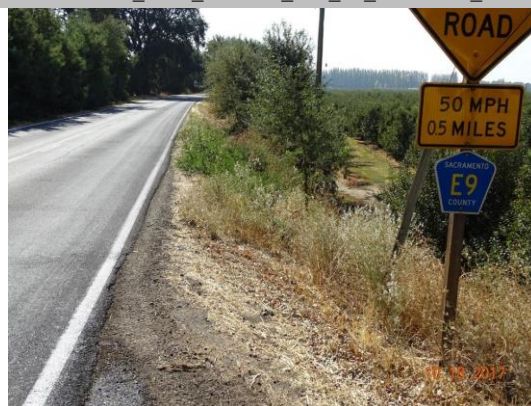
Photo 1 of 2 : SP_2018_RD0349_204_23_20180305_00010.jpg

LM Start	0.01	Rating **	U	Issue No.	23
LM End	0.68	Issue Type +	Ma	Location *	LS
Category	Earthen Levee			GPS Latitude/Longitude	
				Start	End
Item	Vegetation			38.327054 °	38.317598 °
				-121.577032 °	-121.579134 °
DWR ID	DWR_RD0349_01_f_2017_23				
Comment Code					
V1 : Control annual grass and weeds on the levee slopes and easements.					
Inspector Comment					
Landside vegetation should be cleared to allow inspection and access.

Landside vegetation should be cleared to allow inspection and access.

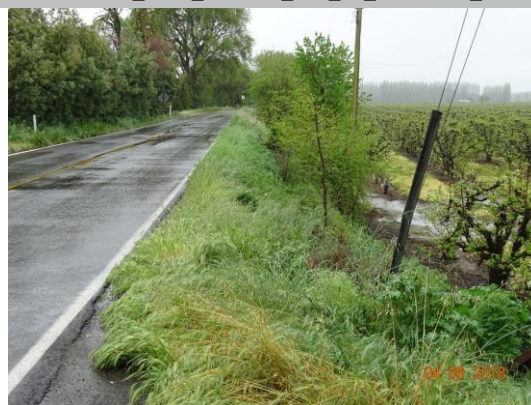
Photo 2 of 2 : SP_2018_RD0349_204_23_20180409_00034.jpg

Landside vegetation has not been managed.

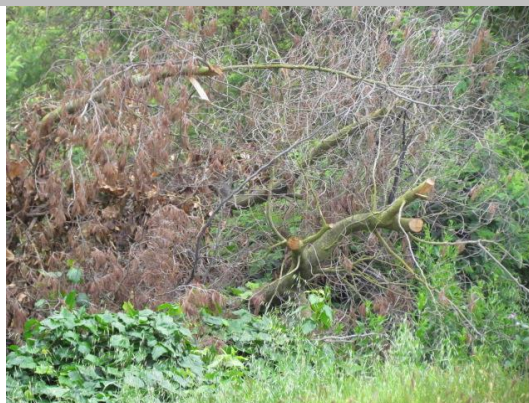
Photo 1 of 1 : SP_2018_RD0349_204_11_20180305_00001.jpg

LM Start	0.04	Rating **	U	Issue No.	11
LM End	0.04	Issue Type +	En	Location *	WS
Category	Earthen Levee			GPS Latitude/Longitude	
				Start	End
Item	Encroachments			38.326638 °	38.326638 °
				-121.577001 °	-121.577001 °
DWR ID	DWR_RD0349_01_s_2017_11				
Comment Code					
TR : Tree or limb					
Inspector Comment					
Remove the dead fallen tree from the waterside levee section.

Waterside slope fallen dead tree branches cut up and remains on the levee slope.

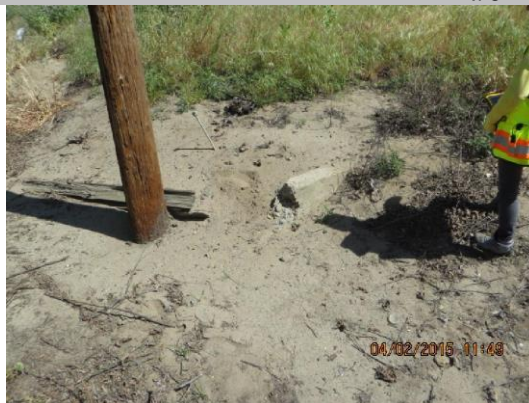
Photo 1 of 3 : UCIP_SP_2018_44303_73622.jpg

Comment Code					
Inspector Comment					
FS_ID:44303					
DS_ID:24137					
EP_NO: N/A					
Repair Type: Non-Urgent					
Crossing Status: Indicator Found					
UCIP Comments: Pipe appears to be abandoned and if so should be done so properly. Electromagnetic survey indicated a crossing at this location.					
FIELD_STRUCT_DESC: *ABANDONED* 10-inch irrigation pipe of unknown material through the levee, 3.8 feet below the levee crown. Power pole and anchor on the landside (LS). Deteriorated concrete box at the LS toe. Concrete debris on the waterside (WS) toe good indicator of pump location. [Additional Reference(s): DWR Levee Log, 2005. USACE Sacramento O&M Manual Unit No. 110, May 1959, revised 29 Dec 2016, (HLM 0.1)]					
FS Date: 4/2/2015

Deteriated concrete distribution box on LS toe next to power pole.

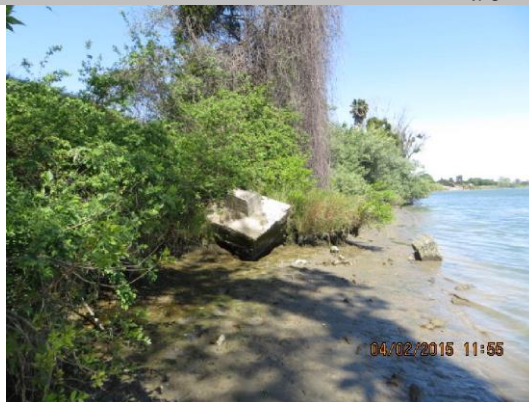
Photo 2 of 3 : UCIP_SP_2018_44303_73621.jpg

Concrete debris on WS toe is a good indicator of pump location.

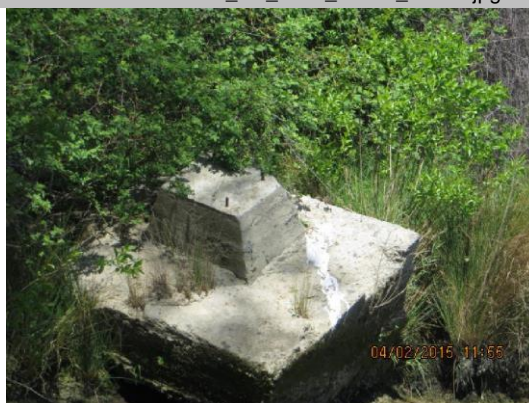
Photo 3 of 3 : UCIP_SP_2018_44303_73620.jpg

Comment Code						
Inspector Comment						
FS_ID:44303 DS_ID:24137 EP_NO: N/A Repair Type: Non-Urgent Crossing Status: Indicator Found UCIP Comments: Pipe appears to be abandoned and if so should be done so properly. Electromagnetic survey indicated a crossing at this location. FIELD_STRUCT_DESC: *ABANDONED* 10-inch irrigation pipe of unknown material through the levee, 3.8 feet below the levee crown. Power pole and anchor on the landside (LS). Deteriorated concrete box at the LS toe. Concrete debris on the waterside (WS) toe good indicator of pump location. [Additional Reference(s): DWR Levee Log, 2005. USACE Sacramento O&M Manual Unit No. 110, May 1959, revised 29 Dec 2016, (HLM 0.1)] FS Date: 4/2/2015

Concrete debris on WS toe is a good indicator of pump location.

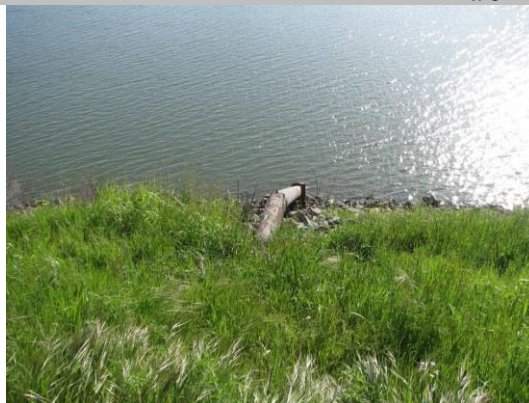
Photo 1 of 3 : UCIP_SP_2018_50062_36547.jpg

Comment Code					
Inspector Comment					
FS_ID:50062 DS_ID:24139 EP_NO: 951 Repair Type: Non-Urgent Crossing Status: Found UCIP Comments: 8/22/2016 Meet Fred Wheeler with RD349 at this crossing. Crossing is active. Crossing was downgraded from Urgent to Non-Urgent -- no signs of pipe failure visible on surface. Need to contact owner -- dense vegetation on WS and LS should be cleared prior to next inspection. Need to coordinate with owner regarding the 8-inch sleeved pipe--need permit number to update record. (DWR UCIP - omagana)3/18/2009 Exposed section of levee slope on LS--need to contact owner and DWR inspector. Burrow activity noticed at crossing 10 inch holes. Dense vegetation limits the inspector's visibility to identify signs of pipe failure (leaks) along the slope. Recommend removing vegetation along pipe alignment to conduct proper inspection of structure and appurtenances. Note date on photos should be 3/18/09 not 7/26/08 camera metadata is incorrect. (DWR UCIP - omagana) FIELD_STRUCT_DESC: 8-inch steel drainage pipe measured (instead of 10-inch) sleeved through a 12-inch steel pipe, 6.6 feet below the crown. Annular gap grouted at both ends. Active centrifugal pump on platform at landside (LS) toe. Inactive slant pump on steel platform on waterside (WS) slope (not present in 2008 referenced in USACE O&M manual). Exposed section pipe on WS slope. Service pole on the LS slope. (10-inch pipe sleeved through pre-existing 12-pipe under Permit No. 3382, 1960 - Davis J. Eliot and Son; 12-inch pipe authorized in under Permit No. 951, 1944 - Stillwater Orgards Company). [Additional Reference(s): DWR Levee Log, 2005. USACE San Joaquin O&M Manual Unit No. 110, May 1959, (HLM 0.5), 12-inch pipe]. FS Date: 8/17/2016

View of pipe on WS with rip rap on toe--dense vegetation on slope.

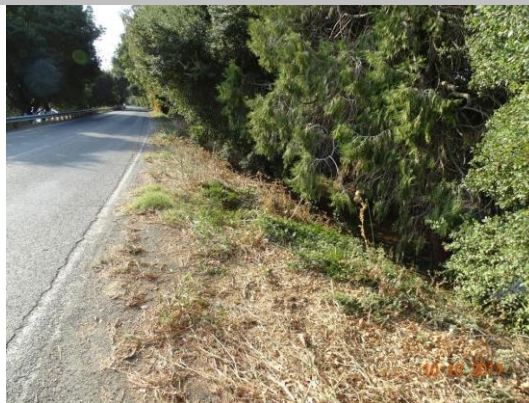
Photo 1 of 1 : SP_2018_RD0349_204_18_20180305_00007.jpg

LM Start	0.73	Rating **	M	Issue No.	18
LM End	1.06	Issue Type +	Ma	Location *	LS
Category	Earthen Levee			GPS Latitude/Longitude	
				Start	End
Item	Trim / Thin Trees			38.316821 °	38.311992 °
				-121.579161 °	-121.578460 °
DWR ID	DWR_RD0349_01_f_2017_18				
Comment Code					
T1 : Trim trees to at least five feet above ground level.					
Inspector Comment

Trim and thin trees on landside slope.

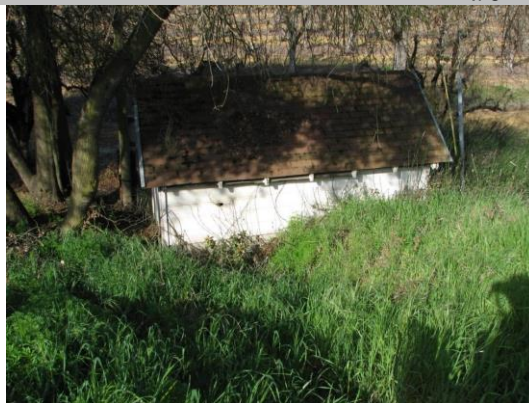
Photo 2 of 3 : UCIP_SP_2018_21572_36573.jpg

Comment Code						
Inspector Comment						
FS_ID:21572 DS_ID:24521 EP_NO: N/A Repair Type: Non-Urgent Crossing Status: Found UCIP Comments: No records were found during intial desk study--need to contact owner to obtain permit number authorizing work. If crossing is no longer used by owner, the owner will need to coordinate with DWR Inspector and CVFPB to remove crossing according to Title 23 requirements. Dense vegetation limits the inspector's visibility to identify signs of pipe failure (leaks) along the slope. Recommend removing vegetation along pipe alignment to conduct proper inspection of structure and appurtenances. Note date on photos should be 3/18/09 not 7/26/08 camera metadata is incorrect. FIELD_STRUCT_DESC: *ABANDONED* 8-inch irrigation pipe of unknown material through the levee, 13.9 feet below the levee crown. Pump on platform at landside (LS) toe. Service pole on LS slope. FS Date: 3/18/2009

Pump house located on landward side at toe.

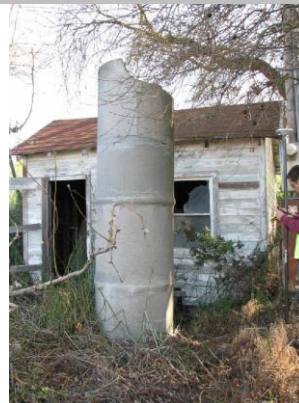
Photo 3 of 3 : UCIP_SP_2018_21572_36578.jpg

View of pump house, concrete stand pipe, and utility pole.

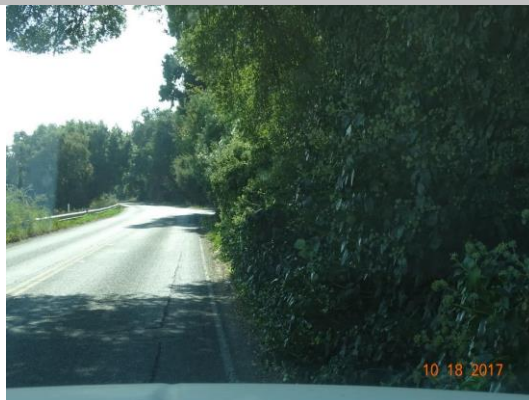
Photo 1 of 1 : SP_2018_RD0349_204_27_20180305_00012.jpg

LM Start	0.98	Rating **	U	Issue No.	27
LM End	0.98	Issue Type +	En	Location *	LS
Category	Earthen Levee			GPS Latitude/Longitude	
				Start	End
Item	Vegetation			38.313200 °	38.313200 °
				-121.578797 °	-121.578797 °
DWR ID	DWR_RD0349_01_f_2017_27				
Comment Code					
V6 : Landscaping					
Inspector Comment					
Landside landscaping must be removed or trimmed to allow inspection and access.

Landside landscaping must be removed or trimmed to allow inspection and access.

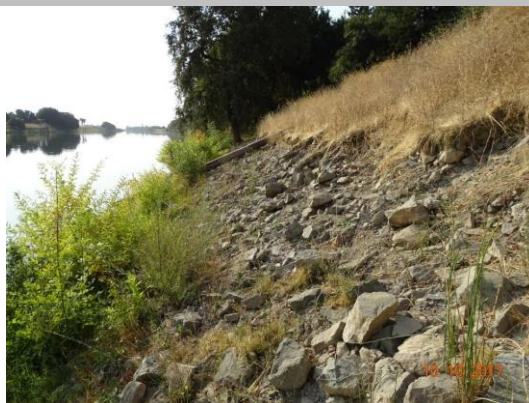
Photo 1 of 1 : SP_2018_RD0349_204_15_20180305_00004.jpg

Comment Code						
Inspector Comment						
Levee Evaluation Comments						
Description:District Station 52+92 to 55+88, Sec. 06, T. 5 N. R. 4 E., M.D.M. Approximately 296 linear-feet of eroded area exists along the waterside levee slope of the Sacramento River (Unit 1). Erosion commences at approximately 3/4 of the way down the slope from the crown and extends into the rip rap. Some rip rap has been pulled off in this section.						
Site ID No:318						
Site Designation:LMA-145						
Repair Type: Erosion						
Rating:Area of Concern						
Field Date:7/28/2017						
Notes: slope too steep, vegetation too thick for clear inspection, no direct visual of damage

Waterside erosion at LM 1.02.

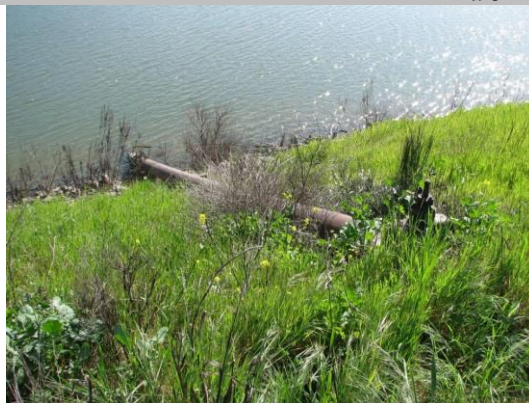
Photo 1 of 3 : UCIP_SP_2018_50013_36561.jpg

Comment Code					
Inspector Comment					
FS_ID:50013 DS_ID:24140 EP_NO: N/A Repair Type: Non-Urgent Crossing Status: Found UCIP Comments: 8/22/2016 Crossing has been downgraded from Urgent to Non-Urgent no signs of pipe failure were visible during site inspection. Minor erosion visible on LS shoulder covered by dry leaves. No permit was found--need to contact owner to determine age of crossing and determine when the last internal inspeciton was completed. (DWR UCIP - omagana)8/13/2009 Exposed section of levee slope on LS--need to contact owner and DWR inspector. Dense vegetation limits the inspector's visibility to identify signs of pipe failure (leaks) along the slope. Recommend removing vegetation along pipe alignment to conduct proper inspection of structure and appurtenances. Note date on photos should be 3/18/09 not 7/26/08 camera metadata is incorrect. (DWR UCIP - omagana) FIELD_STRUCT_DESC: 14-inch steel irrigation pipe (waterside (WS) shoulder) and 12-inch pipe (landside (LS) shoulder) through the levee, 4.7 feet below the levee crown. Gate valve on the WS slope. Pump in pump house on LS slope. Pressure breaker behind pump house. Pipe exposed on WS slope. [Additional Reference(s): DWR Levee Log, 2005. USACE San Joaquin O&M Manual Unit No. 110, May 1959, HLM 1.1, 14-inch pipe with pump on WS] FS Date: 8/17/2016

View of pipe on WS.

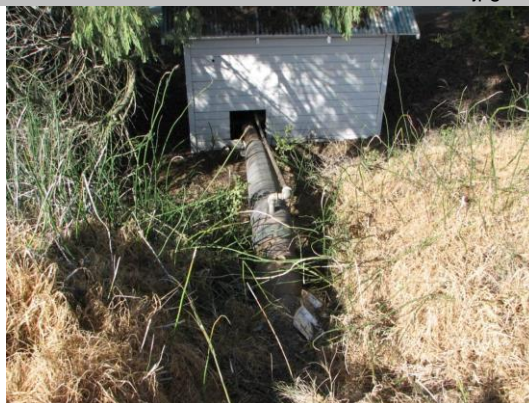
Photo 2 of 3 : UCIP_SP_2018_50013_36558.jpg

View of LS slope--open cut.

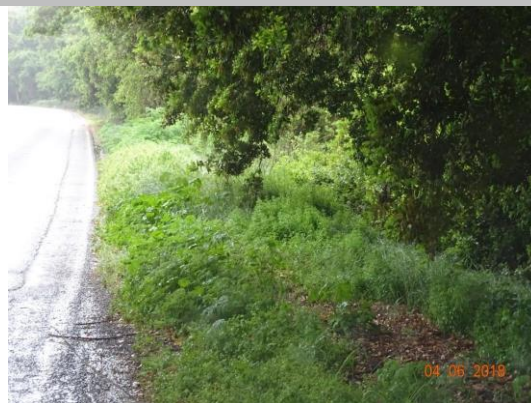
Photo 1 of 1 : SP_2018_RD0349_204_29_20180409_00036.jpg

LM Start	1.11	Rating **	U	Issue No.	29
LM End	1.21	Issue Type +	Ma	Location *	LS
Category	Earthen Levee			GPS Latitude/Longitude	
				Start	End
Item	Vegetation			38.311366 °	38.309955 °
				-121.578230 °	-121.577495 °
DWR ID	DWR_RD0349_01_f_2017_29				
Comment Code					
V2 : Remove the wild growth other than native grasses from the levee slopes.					
Inspector Comment

Manage landside vegetation to allow inspection and access.

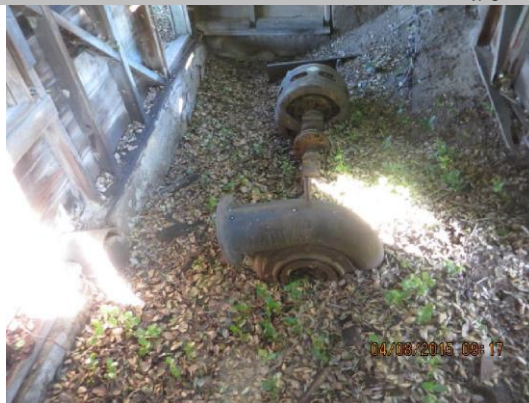
Photo 3 of 3 : UCIP_SP_2018_44304_73680.jpg

Comment Code						
Inspector Comment						
FS_ID:44304						
DS_ID:24141						
EP_NO: N/A						
Repair Type: Non-Urgent						
Crossing Status: Found						
UCIP Comments: 2007 DWR erosion repair site location?--need to find out fate of crossing. Dense vegetation limits the inspector's visibility to identify signs of pipe failure (leaks) along the slope. Recommend removing vegetation along pipe alignment to conduct proper inspection of structure and appurtenances. Note date on photos should be 3/18/09 not 7/26/08 camera metadata is incorrect.						
FIELD_STRUCT_DESC: *ABANDONED* Pump house located on landside (LS) toe. Pressure breaker on LS. Electromagnetic Survey indicates a crossing at this location. [Additional Reference(s): DWR Levee Log, 2005]						
FS Date: 4/2/2015

Pump and motor inside pumphouse at LS toe. No pipe visible.

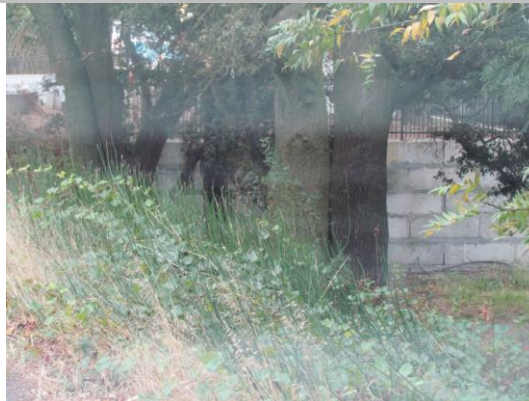
Photo 1 of 1 : SP_2018_RD0349_204_12_20180305_00002.jpg

LM Start	1.54	Rating **	U	Issue No.	12
LM End	1.54	Issue Type +	En	Location *	LS
Category	Earthen Levee			GPS Latitude/Longitude	
				Start	End
Item	Encroachments			38.305722 °	38.305722 °
				-121.574680 °	-121.574695 °
DWR ID	DWR_RD0349_01_f_2014_12				
Comment Code					
RW : Retaining Wall					
Inspector Comment					
This issue is under review with the CVFPB. No change.

Looking downstream at levee mile 1.55 unauthorized block wall placed on landward levee section, no CVFPB Permit.

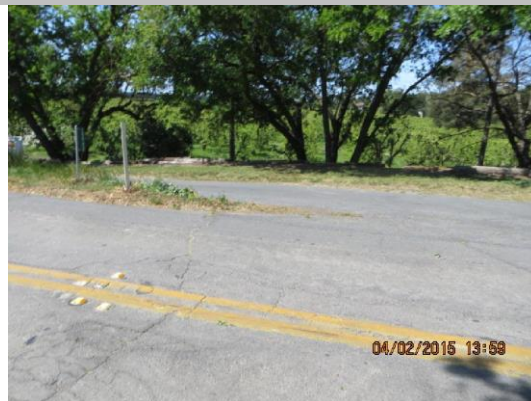
Photo 3 of 3 : UCIP_SP_2018_46169_74547.jpg

LM Start	0.04	Rating **	M	Issue No.	87 (cont)	
LM End	0.04	Issue Type +	En	Location *		
Category	Supplemental			GPS Latitude/Longitude		
				Start	End	
Item	DWR UCIP Field Study			38.304885 °	38.304885 °	
				-121.575369 °	-121.575369 °	
DWR ID						
Comment Code						
Inspector Comment						
FS_ID:46169						
DS_ID:25098						
EP_NO: N/A						
Repair Type: Non-Urgent						
Crossing Status: Found						
UCIP Comments: Appears abandoned and if so should be done so properly. Need to identify permit.						
FIELD_STRUCT_DESC: 1-inch waterline of unknown material through the levee, 1.5-feet below the levee crown. Pipe visible at fence on waterside (WS) slope.						
FS Date: 4/9/2015

Approximate location of pipe alignment on LS of crown.

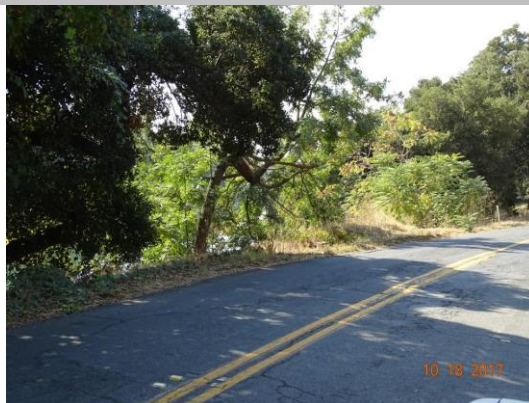
Photo 1 of 1 : SP_2018_RD0349_205_44_20180305_00041.jpg

LM Start	0.04	Rating **	M	Issue No.	44
LM End	0.08	Issue Type +	Ma	Location *	WS
Category	Earthen Levee			GPS Latitude/Longitude	
				Start	End
Item	Vegetation			38.304877 °	38.304719 °
				-121.575384 °	-121.576083 °
DWR ID	DWR_RD0349_02_f_2017_44				
Comment Code					
V2 : Remove the wild growth other than native grasses from the levee slopes.					
Inspector Comment					
Waterside vegetation should be removed or thinned to 20 feet from crown to allow inspection and access.

Waterside vegetation should be removed or thinned to 20 feet from crown to allow inspection and access.

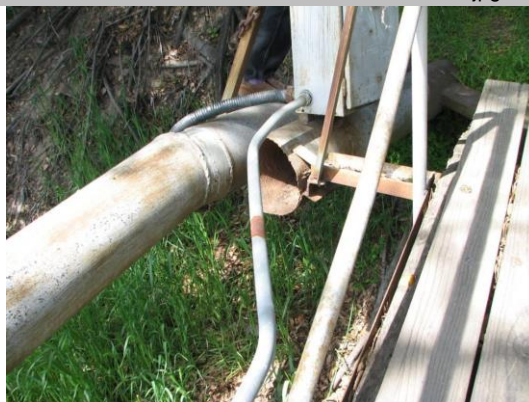
Photo 2 of 3 : UCIP_SP_2018_21576_36592.jpg

Pipes through levee at waterward slope.

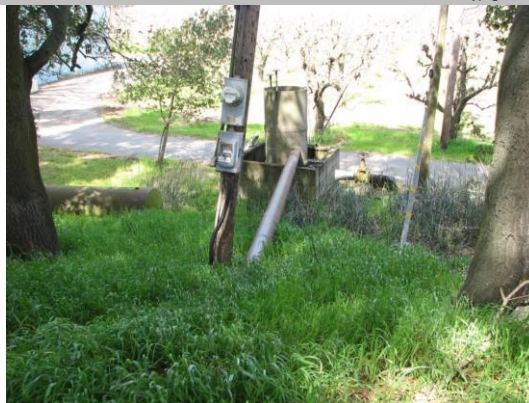
Photo 3 of 3 : UCIP_SP_2018_21576_36591.jpg

Comment Code						
Inspector Comment						
FS_ID:21576 DS_ID:24145 EP_NO: N/A Repair Type: Non-Urgent Crossing Status: Found UCIP Comments: No connection present--need to contact owner to determine if owner plans to use. If crossing is no longer in use owner will need to coordinate with DWR inspector and CVFPB to remove according to Title 23 requirements. Dense vegetation limits the inspector's visibility to identify signs of pipe failure (leaks) along the slope. Recommend removing vegetation along pipe alignment to conduct proper inspection of structure and appurtenances. Unable to determine if crossing is in use. Note date on photos should be 3/18/09 not 7/26/08 camera metadata is incorrect. FIELD_STRUCT_DESC: *ABANDONED* 10-inch irrigation pipe through the levee, 6.0 feet below the levee crown. Pump and slide gate are located on the waterside (WS) slope. Concrete pipe riser and distribution box located on the landside (LS) toe. Service pole and anchor on the LS slope. [Additional Reference(s): DWR Levee Log, 2005] FS Date: 3/18/2009

Multiple appurtenances found on landward side-standpipe, electrical pole, valve, concrete distribution box.

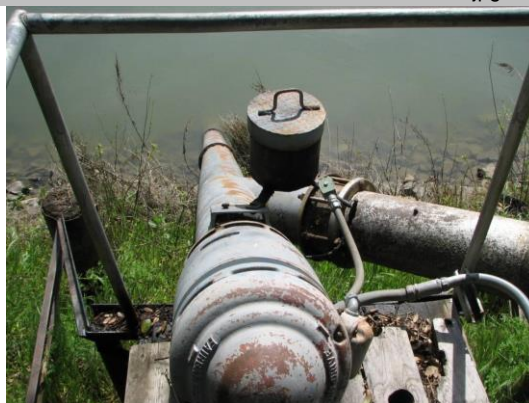
Photo 2 of 3 : UCIP_SP_2018_21577_36596.jpg

Comment Code						
Inspector Comment						
FS_ID:21577 DS_ID:24146 EP_NO: 2480 Repair Type: Non-Urgent Crossing Status: Found UCIP Comments: Dense vegetation limits the inspector's visibility to identify signs of pipe failure (leaks) along the landward slope. Recommend removing vegetation along pipe alignment to conduct proper inspection of structure and appurtenances. Unable to determine if crossing is in use. Note date on photos should be 3/18/09 not 7/26/08 camera metadata is incorrect. FIELD_STRUCT_DESC: 10-inch steel irrigation pipe through the levee, 6.0 feet below the levee crown. Pump and slide gate on the waterside (WS) slope. Concrete pipe riser and distribution box with gate valve located on the landside (LS) toe. Service pole and anchor on the LS slope. (10-inch pipe installed under Permit No. 2480, 1959 - L. C. Peck) [Additional Reference(s): DWR Levee Log, 2005] FS Date: 3/18/2009

View of waterward side--pump and raised platform.

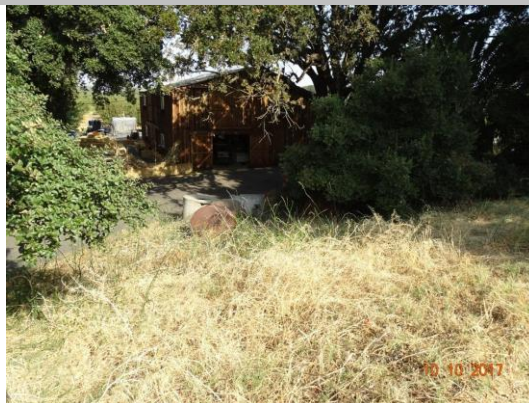
Photo 1 of 1 : SP_2018_RD0349_205_46_20180305_00043.jpg

LM Start	0.11	Rating **	M	Issue No.	46
LM End	0.11	Issue Type +	En	Location *	LS
Category	Earthen Levee			GPS Latitude/Longitude	
				Start	End
Item	Encroachments			38.304450 °	38.304450 °
				-121.576562 °	-121.576562 °
DWR ID	DWR_RD0349_02_s_2016_46				
Comment Code					
EQ : Equipment					
Inspector Comment					
Move the equipment away from the levee toe.

Equipment at landside levee toe.

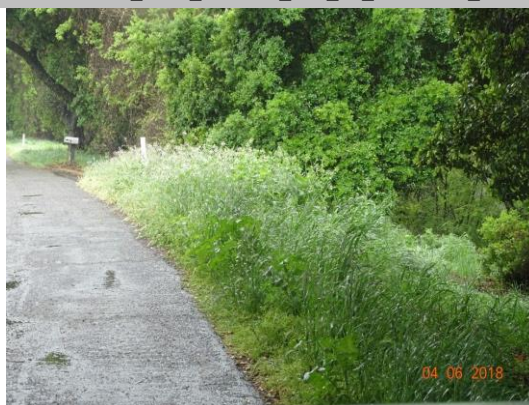
Photo 1 of 1 : SP_2018_RD0349_205_71_20180409_00114.jpg

LM Start	0.12	Rating **	U	Issue No.	71
LM End	0.12	Issue Type +	Ma	Location *	LS
Category	Earthen Levee			GPS Latitude/Longitude	
				Start	End
Item	Vegetation			38.304402 °	38.304402 °
				-121.576753 °	-121.576753 °
DWR ID	DWR_RD0349_02_s_2018_71				
Comment Code					
V1 : Control annual grass and weeds on the levee slopes and easements.					
Inspector Comment

Manage landside vegetation to allow inspection and access.

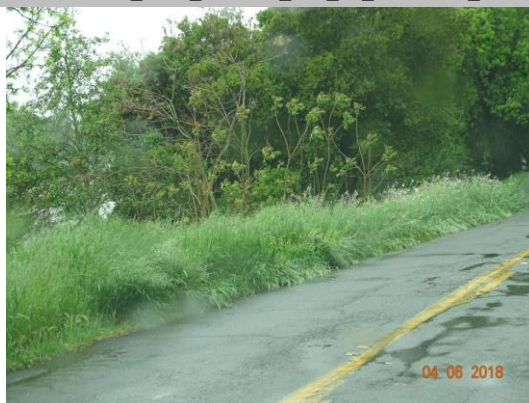
Photo 1 of 1 : SP_2018_RD0349_205_72_20180409_00115.jpg

LM Start	0.12	Rating **	U	Issue No.	72
LM End	0.17	Issue Type +	Ma	Location *	WS
Category	Earthen Levee			GPS Latitude/Longitude	
				Start	End
Item	Vegetation			38.304405 °	38.303999 °
				-121.576763 °	-121.577367 °
DWR ID	DWR_RD0349_02_s_2018_72				
Comment Code					
V1 : Control annual grass and weeds on the levee slopes and easements.					
Inspector Comment

Reduce waterside vegetation to 20' from crown.

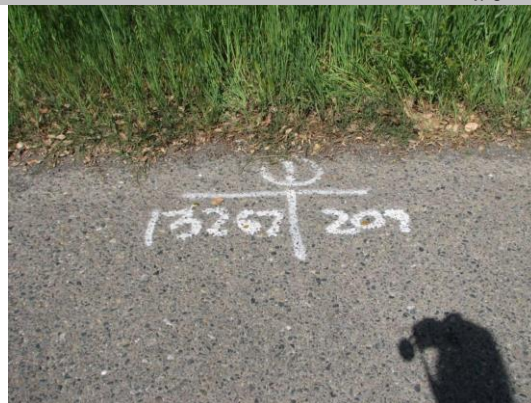
Photo 1 of 3 : UCIP_SP_2018_21613_36685.jpg

Comment Code						
Inspector Comment						
FS_ID:21613						
DS_ID:24147						
EP_NO: N/A						
Repair Type: Non-Urgent						
Crossing Status: Found						
UCIP Comments: Dense vegetation limits the inspector's visibility to identify signs of pipe failure (leaks) along the slope. Recommend removing vegetation along pipe alignment to conduct proper inspection of structure and appurtenances. Note date on photos should be 3/18/09 not 7/26/08 camera metadata is incorrect.						
FIELD_STRUCT_DESC: 3-inch steel siphon irrigation pipe through the levee, 3.3 feet below the levee crown. Gate valve on landside (LS).						
[Additional Reference(s): DWR Levee Log, 2005. USACE Sacramento O&M Manual Unit No. 110, May 1959, revised 29 Dec 2016, (HLM 0.1)]						
FS Date: 3/18/2009

Underground service alert (USA) marking on levee crown.

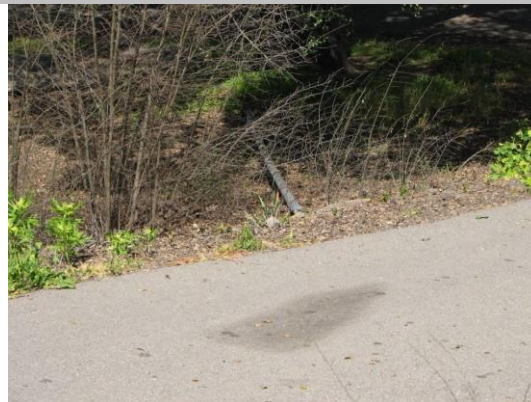
Photo 2 of 3 : UCIP_SP_2018_21613_36687.jpg

View of crossing on landward side.

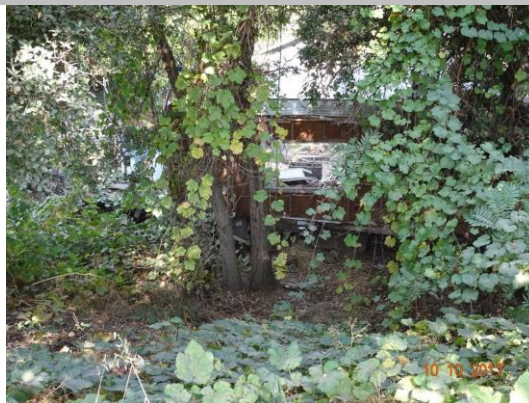
Photo 1 of 1 : SP_2018_RD0349_205_73_20180305_00057.jpg

LM Start	0.16	Rating **	M	Issue No.	73
LM End	0.16	Issue Type +	En	Location *	LS
Category	Earthen Levee			GPS Latitude/Longitude	
				Start	End
Item	Encroachments			38.304117 °	38.304117 °
				-121.577263 °	-121.577263 °
DWR ID	DWR_RD0349_02_s_2014_73				
Comment Code					
MA : Material					
Inspector Comment					
Remove the material from the landside levee section.

Material/debris on landside slope.

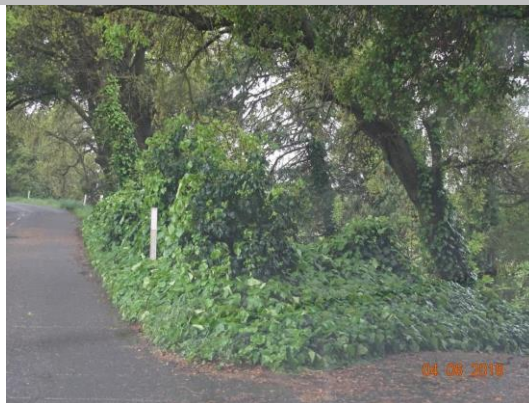
Photo 1 of 1 : SP_2018_RD0349_205_76_20180409_00116.jpg

LM Start	0.22	Rating **	U	Issue No.	76
LM End	0.22	Issue Type +	En	Location *	LS
Category	Earthen Levee			GPS Latitude/Longitude	
				Start	End
Item	Vegetation			38.303528 °	38.303528 °
				-121.578179 °	-121.578179 °
DWR ID	DWR_RD0349_02_s_2018_76				
Comment Code					
V6 : Landscaping					
Inspector Comment					
Thick ivy prevents inspection and access. Should be removed.

Landside ivy should be reduced to allow inspection and access.

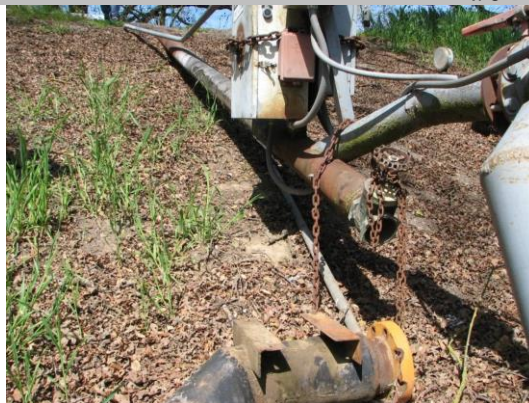
Photo 2 of 3 : UCIP_SP_2018_21614_36690.jpg

FS_ID:21614
DS_ID:24148
EP_NO: 12006
Repair Type: Non-Urgent
Crossing Status: Found
UCIP Comments: Altered crossing--contact owner to obtain new permit authoring work. Debris remains on site. Dense vegetation limits the inspector's visibility to identify signs of pipe failure (leaks) along the slope. Recommend removing vegetation along pipe alignment to conduct proper inspection of structure and appurtenances. Note date on photos should be 3/18/09 not 7/26/08 camera metadata is incorrect. FIELD_STRUCT_DESC: 6-inch steel irrigation pipe through the levee, 4 feet below the levee crown. 3-inch conduit through levee to service pump. Steel cutoff wall around pipe at center of levee. Siphon breaker in concrete riser at landside (LS) shoulder. Gate valve on LS. Pump on concrete pad on waterside (WS) slope. Discharge structure at LS toe. (pump with 6-inch pipe authorized under Permit No. 12006, 1977 - Carel Van Loben Sels) [Additional Reference(s): DWR Levee Log, 2005]

Crossing has been altered--abandoned pipe through levee slope remains.

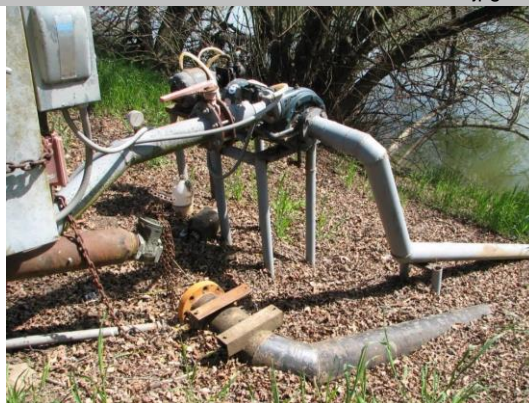
Photo 3 of 3 : UCIP_SP_2018_21614_36689.jpg

New configuration--sections of pipe have been abandoned.

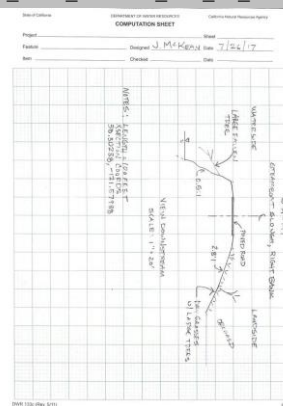
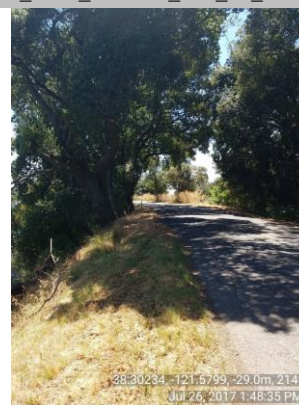
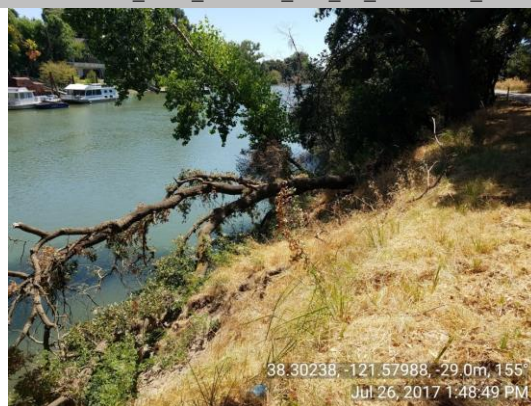
LM Start	0.35	Rating **	A/W	Issue No.	32
LM End	0.37	Issue Type +	Ma	Location *	
Category	Supplemental		GPS Latitude/Longitude		
			Start	End	
Item	2017 Storm Damage		38.302217°	38.302017°	
			-121.579847°	-121.580017°	
DWR ID	DWR_RD0349_02_f_2017_32				
Comment Code					
Inspector Comment					
<p>Levee Evaluation Comments</p> <p>Description: District Station 19+13 to 20+07, Sec. 07, T. 5 N. R. 4 E., M.D.M. . Approximately 94 linear feet of erosion exists on the water side slope of the Steamboat Slough levee (Unit 2). The erosion area commences approximately halfway down the slope from the levee crown and extends to the waterside toe. No rip rap is visible in this area.</p> <p>Site ID No: 320</p> <p>Site Designation: LMA-147</p> <p>Repair Type: Erosion</p> <p>Rating: Critical</p> <p>Field Date: 7/26/2017</p> <p>Notes: fallen tree present</p>

LM Start	0.35	Rating **	A/W	Issue No.	32 (cont)	
LM End	0.37	Issue Type +	Ma	Location *		
Category	Supplemental			GPS Latitude/Longitude		
				Start	End	
Item	2017 Storm Damage			38.302217 °	38.302017 °	
				-121.579847 °	-121.580017 °	
DWR ID	DWR_RD0349_02_f_2017_32					
Comment Code						
Inspector Comment						
Levee Evaluation Comments						
Description: District Station 19+13 to 20+07, Sec. 07, T. 5 N. R. 4 E., M.D.M. . Approximately 94 linear feet of erosion exists on the water side slope of the Steamboat Slough levee (Unit 2). The erosion area commences approximately halfway down the slope from the levee crown and extends to the waterside toe. No rip rap is visible in this area.						
Site ID No:320						
Site Designation:LMA-147						
Repair Type: Erosion						
Rating:Critical						
Field Date:7/26/2017						
Notes: fallen tree present

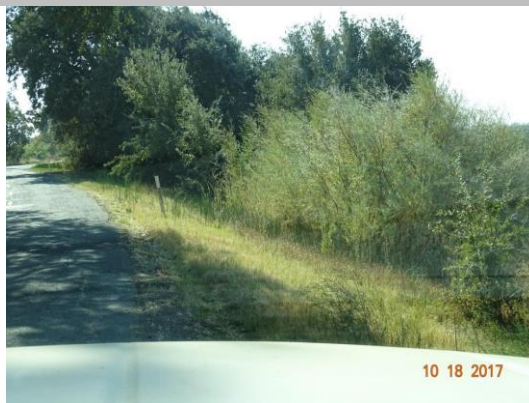
Photo 1 of 1 : SP_2018_RD0349_205_52_20180305_00046.jpg

LM Start	0.71	Rating **	M	Issue No.	52
LM End	0.71	Issue Type +	Ma	Location *	LS
Category	Earthen Levee			GPS Latitude/Longitude	
				Start	End
Item	Trim / Thin Trees			38.297441 °	38.297441 °
				-121.582451 °	-121.582451 °
DWR ID	DWR_RD0349_02_f_2017_52				
Comment Code					
T1 : Trim trees to at least five feet above ground level.					
Inspector Comment					
Landside trees should be trimmed and maintained to allow inspection and access to levee slope and toe.

Landside trees should be trimmed and maintained to allow inspection and access to levee slope and toe.

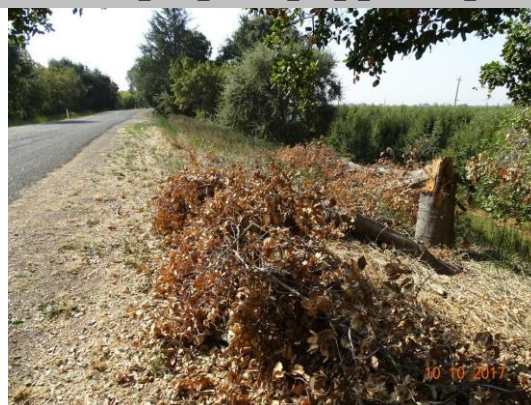
Photo 1 of 1 : SP_2018_RD0349_205_7_20180305_00008.jpg

LM Start	0.93	Rating **	M	Issue No.	7
LM End	0.93	Issue Type +	Ma	Location *	LS
Category	Earthen Levee			GPS Latitude/Longitude	
				Start	End
Item	Encroachments			38.294385 °	38.294385 °
				-121.583351 °	-121.583351 °
DWR ID	DWR_RD0349_02_f_2017_7				
Comment Code					
TR : Tree or limb					
Inspector Comment					
Fallen tree has been removed from road, but currently obstructs visibility and access to landside slope. Smaller branches/foliage are stacked along both roadway shoulders. All debris should be removed from levee.

Fallen tree on landside slope.

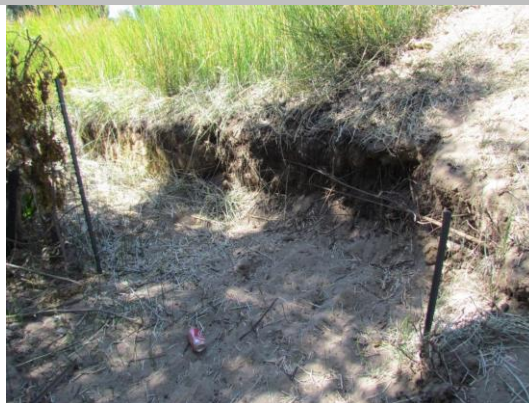
Photo 1 of 2 : SP_2018_RD0349_205_36_20180305_00025.jpg

LM Start	1.08	Rating **	U	Issue No.	36
LM End	1.08	Issue Type +	En	Location *	WS
Category	Earthen Levee			GPS Latitude/Longitude	
				Start	End
Item	Encroachments			38.292380 °	38.292282 °
				-121.583963 °	-121.583958 °
DWR ID	DWR_RD0349_02_f_2016_36				
Comment Code					
ST : Stairway					
Inspector Comment					
Land owner has excavated and installed stairs on the waterside slope. Stairs should be removed and slope restored to original configuration as soon as possible.

RD 349 Unit 2 waterside slope and berm Land owner has dug a pit.

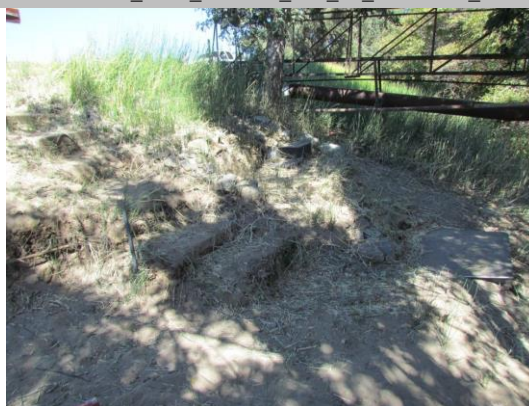
Photo 2 of 2 : SP_2018_RD0349_205_36_20180305_00026.jpg

LM Start	1.08	Rating **	U	Issue No.	36 (cont)	
LM End	1.08	Issue Type +	En	Location *	WS	
Category	Earthen Levee			GPS Latitude/Longitude		
				Start		End
Item	Encroachments			38.292380 °		38.292282 °
				-121.583963 °		-121.583958 °
DWR ID	DWR_RD0349_02_f_2016_36					
Comment Code						
ST : Stairway						
Inspector Comment						
Land owner has excavated and installed stairs on the waterside slope. Stairs should be removed and slope restored to original configuration as soon as possible.

The landowner has knotted step into the waterside slope.

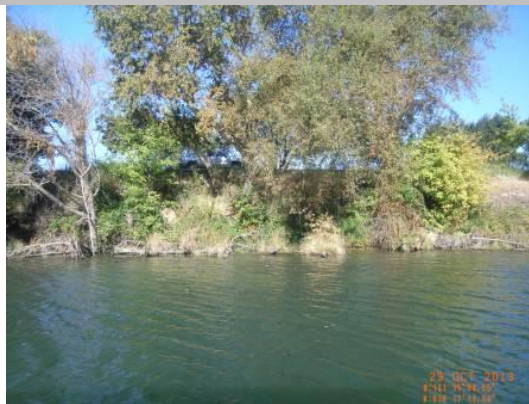
Photo 1 of 1 : SP_2018_RD0349_205_10_20180305_00010.jpg

LM Start	1.33	Rating **	M	Issue No.	40 (cont)	
LM End	1.49	Issue Type +	Ma	Location *		
Category	Supplemental			GPS Latitude/Longitude		
				Start		End
Item	2017 Storm Damage			38.288727 °		38.286475 °
				-121.583823 °		-121.585026 °
DWR ID	DWR_RD0349_02_f_2017_40					
Comment Code						
Inspector Comment						
Levee Evaluation Comments						
Description:						
Site ID No:66						
Site Designation:DWR_RD0349_02_s_2012_28						
Repair Type: Erosion						
Rating:Area of Concern						
Field Date:6/7/2017						
Notes: dense vegetation and large trees hindered visibility; slope riprap appeared failing in some parts

Comment Code					
Inspector Comment					
1997 - Erosion of very sandy levee behind large stand of riparian vegetation on top right bank. Dry ravel of sand. 1999 - Quarry waste rock was dumped down the levee slope; poor repair job; still eroding in places. Eroding at midslope off fabric. 2005 - Length revised, only the middle 150 - 200 ft are eroding. 2006 - Some rock/small material dumped down the bank but it is slowly unraveling. Upstream end is unraveling faster. Steep slope with poor gradation so fines are washing out. 2010 - Lots of overhanging trees and erosion pockets. 2011 - This site is upgraded to CRITICAL. Near vertical bank at the downstream end. New erosion at various locations throughout the site. 2015: No observed changes. [2015 Site ID: STM 24-7 R]

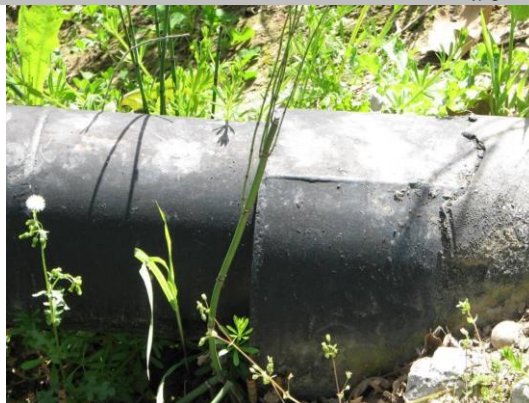
Photo 3 of 3 : UCIP_SP_2018_21606_36657.jpg

Comment Code						
Inspector Comment						
FS_ID:21606 DS_ID:24154 EP_NO: 6274 Repair Type: Non-Urgent Crossing Status: Found UCIP Comments: Crossing appears to have been altered--recommend coordinating with owner to determine records for crossing. Will need permit issued for pipe install. Dense vegetation limits the inspector's visibility to identify signs of pipe failure (leaks) along the slope. Recommend removing vegetation along pipe alignment to conduct proper inspection of structure and appurtenances. Note date on photos should be 3/18/09 not 7/26/08 camera metadata is incorrect. FIELD_STRUCT_DESC: 12-inch steel irrigation pipe through the levee, 3 feet below the crown. Cutoff wall around pipe at waterside (WS) shoulder. Siphon breaker at landside (LS) shoulder. Air vent and pressure breaker on WS slope. Slant pump on the WS slope. Concrete distribution box at LS toe. (12-inch pipe and slant mounted pump installed and existing 8-inch pipe removed under Permit No. 6274, 1974 - P. L. Peck) [Additional Reference(s): DWR Levee Log, 2005] FS Date: 3/18/2009

Pipe sleeved through larger pipe.

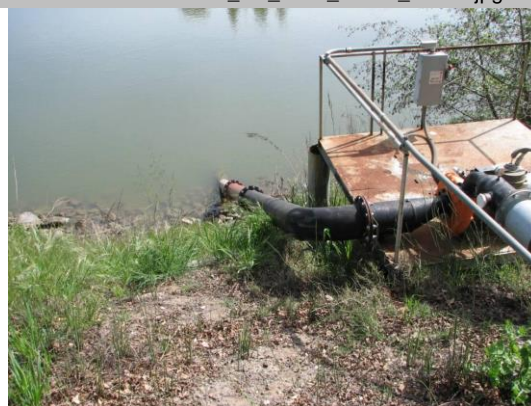
Photo 2 of 3 : UCIP_SP_2018_21607_36659.jpg

Comment Code						
Inspector Comment						
FS_ID:21607 DS_ID:24155 EP_NO: 1116 Repair Type: Non-Urgent Crossing Status: Found UCIP Comments: Dense vegetation limits the inspector's visibility to identify signs of pipe failure (leaks) along the landward slope. Recommend removing vegetation along pipe alignment to conduct proper inspection of structure and appurtenances. Note date on photos should be 3/18/09 not 7/26/08 camera metadata is incorrect. FIELD_STRUCT_DESC: 8-inch steel irrigation pipe through the levee, 4.7 feet below the levee crown. Two concrete cutoff walls under each shoulder. Pressure breaker in concrete riser at levee shoulder. Pump on waterside (WS). (8-inch pipe atuhorized under Permit No. 1116, 1974 - A. C. Ostman). [Additional Reference(s): DWR Levee Log, 2005. USACE Sacramento O&M Manual Unit No. 110, May 1959, revised 29 Dec 2016, (HLM 1.7)] FS Date: 3/18/2009

Pipe at the waterward toe.

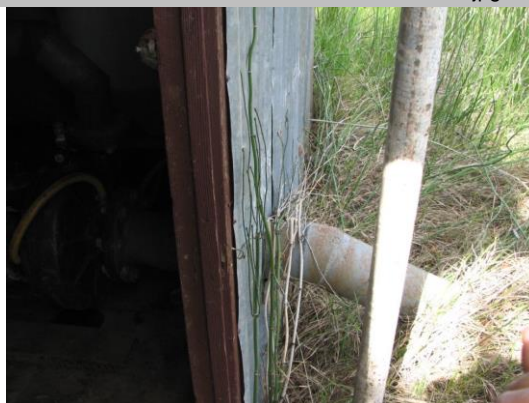
Photo 2 of 3 : UCIP_SP_2018_21608_36663.jpg

FS_ID:21608
DS_ID:24156
EP_NO: N/A
Repair Type: Non-Urgent
Crossing Status: Found
UCIP Comments: Dense vegetation limits the inspector's visibility to identify signs of pipe failure (leaks) along the slope. Recommend removing vegetation along pipe alignment to conduct proper inspection of structure and appurtenances. Note date on photos should be 3/18/09 not 7/26/08 camera metadata is incorrect.
FIELD_STRUCT_DESC: 10-inch steel irrigation pipe through the levee, 3.9 feet below the levee crown. Siphon breaker in concrete riser on the landside (LS) shoulder. Pump and gate valve in pump house on the waterside (WS) slope. [Additional Reference(s): DWR Levee Log, 2005. USACE Sacramento O&M Manual Unit No. 110, May 1959, revised 29 Dec 2016, (HLM 1.9)]
FS Date: 3/18/2009

View of pipe daylight at shed on waterward side.

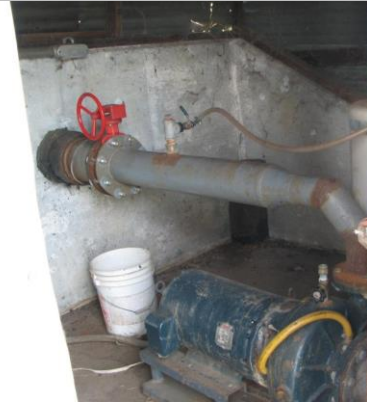
Photo 3 of 3 : UCIP_SP_2018_21608_36665.jpg

Comment Code						
Inspector Comment						
FS_ID:21608 DS_ID:24156 EP_NO: N/A Repair Type: Non-Urgent Crossing Status: Found UCIP Comments: Dense vegetation limits the inspector's visibility to identify signs of pipe failure (leaks) along the slope. Recommend removing vegetation along pipe alignment to conduct proper inspection of structure and appurtenances. Note date on photos should be 3/18/09 not 7/26/08 camera metadata is incorrect. FIELD_STRUCT_DESC: 10-inch steel irrigation pipe through the levee, 3.9 feet below the levee crown. Siphon breaker in concrete riser on the landside (LS) shoulder. Pump and gate valve in pump house on the waterside (WS) slope. [Additional Reference(s): DWR Levee Log, 2005. USACE Sacramento O&M Manual Unit No. 110, May 1959, revised 29 Dec 2016, (HLM 1.9)] FS Date: 3/18/2009

View inside pump house of pipe crossing coming out of levee.

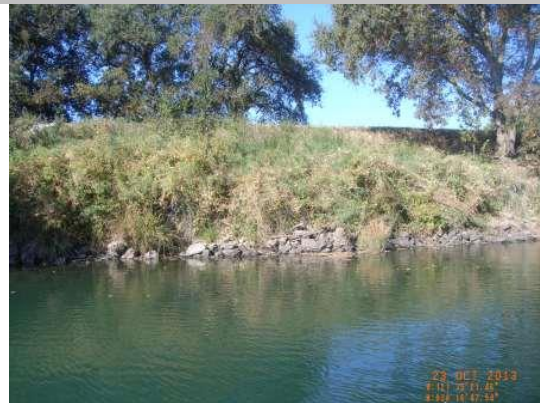
Photo 1 of 1 : SP_2018_RD0349_205_19_20180305_00014.jpg

LM Start	2.04	Rating **	M	Issue No.	19
LM End	2.05	Issue Type +	Ma	Location *	WS
Category	Supplemental			GPS Latitude/Longitude	
				Start	End
Item	2015 USACE Erosion Survey, DRAFT			38.280069 °	38.279919 °
				-121.589443 °	-121.589438 °
DWR ID	DWR_RD0349_02_s_2016_19				
Comment Code					
Inspector Comment					
2011 - Small scallop caused by erosion and wave wash. 2015: No observed changes. [2015 Site ID: STM_24-1_R]

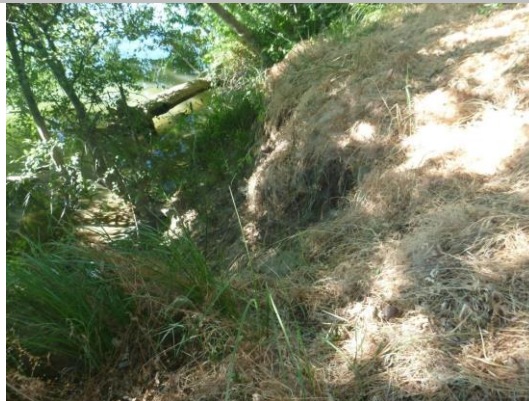
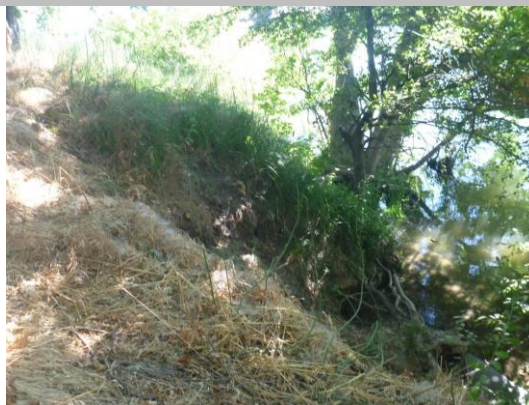
LM Start	2.11	Rating **	A/W	Issue No.	41
LM End	2.13	Issue Type +	Ma	Location *	
Category	Supplemental			GPS Latitude/Longitude	
				Start	End
Item	2017 Storm Damage			38.279039 °	38.278806 °
				-121.589664 °	-121.589783 °
DWR ID	DWR_RD0349_02_f _ 2017_41				
Comment Code					
Inspector Comment					
Levee Evaluation Comments					
Description:District Station 112+11 to 113+04, Sec. 13, T. 5 N. R. 3 E., M.D.M. Approximately 93 linear feet of erosion exists along the water side slope of Steamboat Slough (Unit 2). The erosion area commences approximately 3/4 of the way down the slope from the levee crown and extends to the waterside toe around existing trees. No rip rap is visible in this area.					
Site ID No:324					
Site Designation:LMA-151					
Repair Type: Erosion					
Rating:Serious					
Field Date:7/28/2017					
Notes: no berm

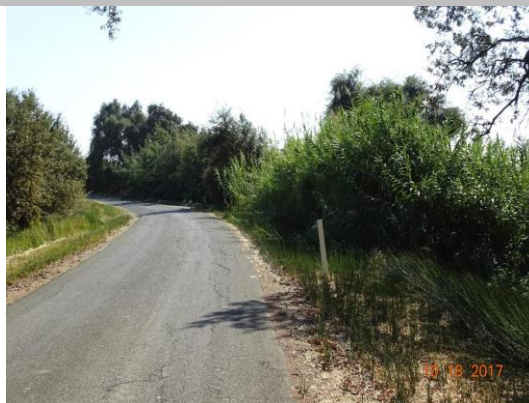
Photo 1 of 1 : SP_2018_RD0349_205_60_20180305_00051.jpg

LM Start	2.37	Rating **	U	Issue No.	60
LM End	2.44	Issue Type +	En	Location *	LS
Category	Earthen Levee			GPS Latitude/Longitude	
				Start	End
Item	Vegetation			38.275713 °	38.274919 °
				-121.591369 °	-121.590622 °
DWR ID	DWR_RD0349_02_f_2017_60				
Comment Code					
V6 : Landscaping					
Inspector Comment					
Arundo and other landscape vegetation blocks visibility and access in most areas. Arondo should be removed; the rest should be thinned.

Arundo and other vegetation blocks visibility and access in most areas.
Arundo should be removed; the rest should be thinned.

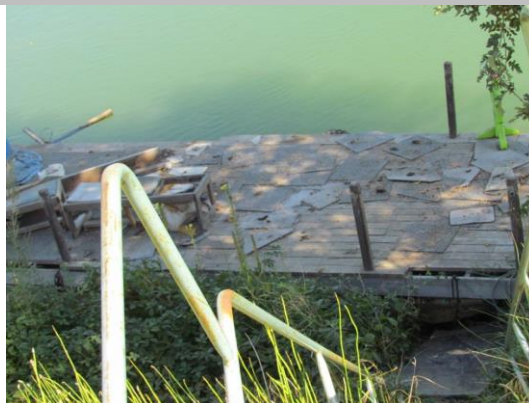
Photo 2 of 3 : SP_2018_RD0349_205_1_20180305_00002.jpg

LM Start	2.39	Rating **	U	Issue No.	1 (cont)	
LM End	2.39	Issue Type +	En	Location *	WS	
Category	Earthen Levee			GPS Latitude/Longitude		
				Start	End	
Item	Encroachments			38.275403 °	38.275403 °	
				-121.591229 °	-121.591229 °	
DWR ID	DWR_RD0349_02_f_2013_1					
Comment Code						
ST : Stairway						
Inspector Comment						
The landowner has installed steps on the waterside slope and has an unauthorized boat dock anchored to the waterside slope.

Unauthorized dock at waterside toe.

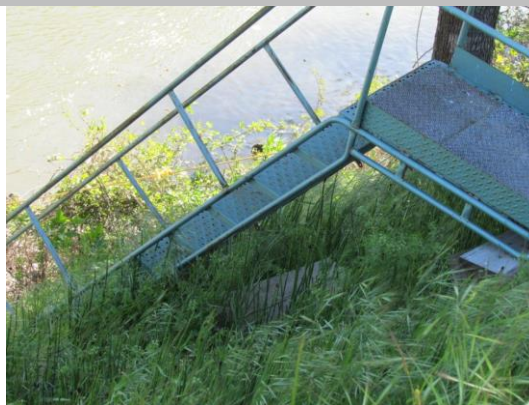
Photo 3 of 3 : SP_2018_RD0349_205_1_20180305_00003.jpg

Unauthorized metal steps on the waterside slope levee mile 2.39.

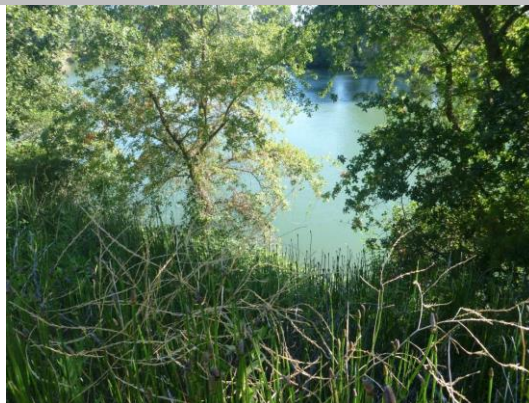
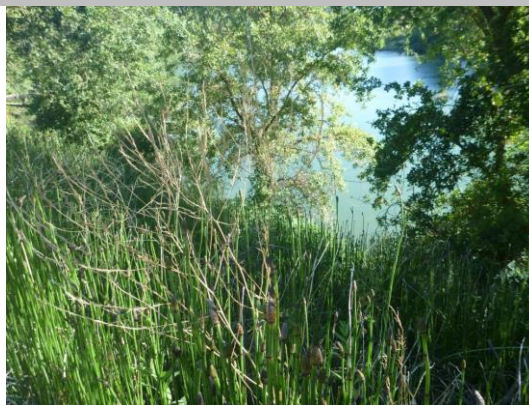
LM Start	2.43	Rating **	A/W	Issue No.	42
LM End	2.44	Issue Type +	Ma	Location *	
Category	Supplemental			GPS Latitude/Longitude	
				Start	End
Item	2017 Storm Damage			38.275131 °	38.275036 °
				-121.590594 °	-121.590461 °
DWR ID	DWR_RD0349_02_f_2017_42				
Comment Code					
Inspector Comment					
Levee Evaluation Comments					
Description:District Station 128+76 to 129+27, Sec. 13, T. 5 N. R. 3 E., M.D.M. Approximately 51 linear feet of erosion exists along the water side slope of Steamboat Slough (Unit 2). The erosion area commences approximately 3/4 of the way down the slope from the levee crown and extends to the waterside toe around existing trees. No rip rap is visible in this area.					
Site ID No:325					
Site Designation:LMA-152					
Repair Type: Erosion					
Rating:Area of Concern					
Field Date:7/28/2017					
Notes: access very difficult, steep slope, dense brush

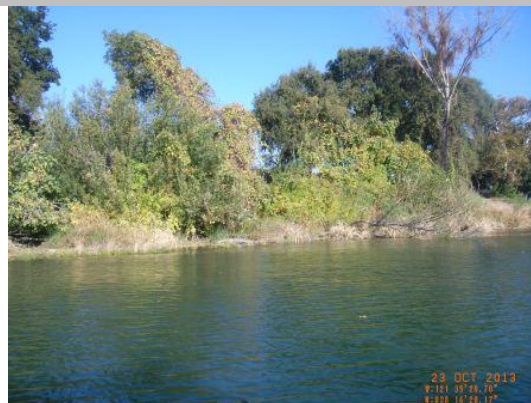
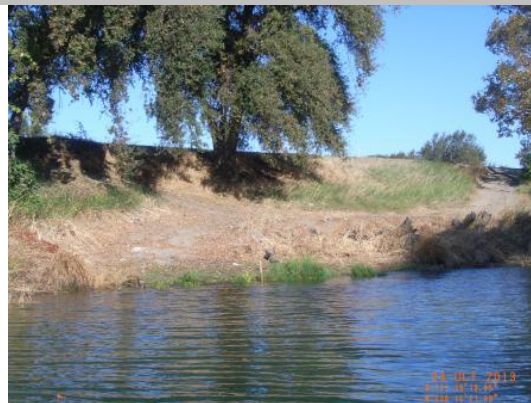
LM Start	2.56	Rating **	A/W	Issue No.	3
LM End	2.69	Issue Type +	Ma	Location *	WS
Category	Supplemental			GPS Latitude/Longitude	
				Start	End
Item	2015 USACE Erosion Survey, DRAFT			38.273854 °	38.271998 °
				-121.588745 °	-121.589424 °
DWR ID	DWR_RD0349_02_s_2016_3				
Comment Code					
Inspector Comment					
2011 - Toe scour at the tidal zone. 2015: New tree popout and minor new erosion. [2015 Site ID: STM_23-6_R]

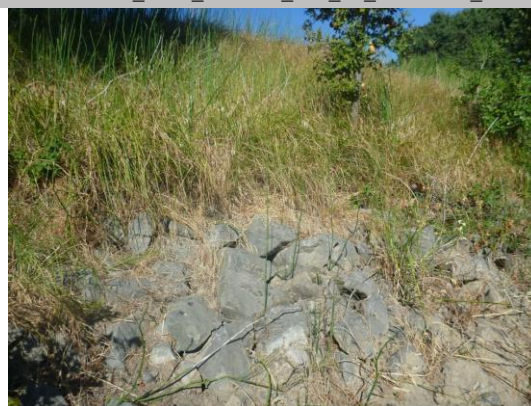
Photo 3 of 3 : SP_2018_RD0349_205_43_20180305_00040.jpg

LM Start	2.56	Rating **	A/W	Issue No.	43 (cont)
LM End	2.59	Issue Type +	Ma	Location *	
Category	Supplemental			GPS Latitude/Longitude	
				Start	End
Item	2017 Storm Damage			38.273769 °	38.273386 °
				-121.588742 °	-121.588672 °
DWR ID	DWR_RD0349_02_f_2017_43				
Comment Code					
Inspector Comment					
Levee Evaluation Comments					
Description:District Station 135+81 to 137+00, Sec. 13, T. 5 N. R. 3 E., M.D.M. Approximately 119 linear feet of sloughing exists due to scour along the water side toe of Steamboat Slough (Unit 2). The erosion area commences approximately 3/4 of the way down the slope from the levee crown and extends to the waterside toe. No rip rap is visible in this area.					
Site ID No:326					
Site Designation:LMA-153					
Repair Type: Erosion					
Rating:Area of Concern					
Field Date:7/28/2017					
Notes: no berm

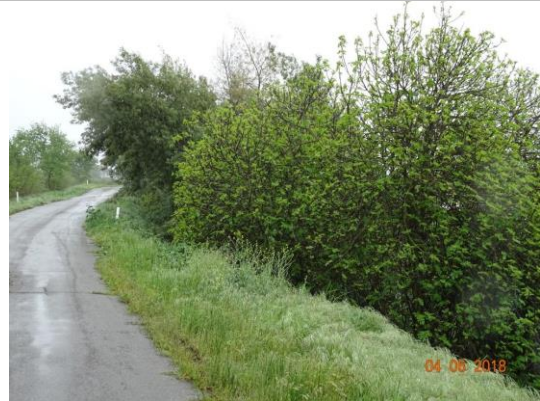
Photo 1 of 1 : SP_2018_RD0349_205_80_20180409_00118.jpg

LM Start	2.99	Rating **	U	Issue No.	80
LM End	3.05	Issue Type +	En	Location *	LS
Category	Earthen Levee			GPS Latitude/Longitude	
				Start	End
Item	Vegetation			38.267938 °	38.267004 °
				-121.588922 °	-121.588470 °
DWR ID	DWR_RD0349_02_s_2018_80				
Comment Code					
V6 : Landscaping					
Inspector Comment					
Dense landscape vegetation and trees should be thinned or removed to allow inspection and access.

Manage landside landscaping to allow inspection and access.

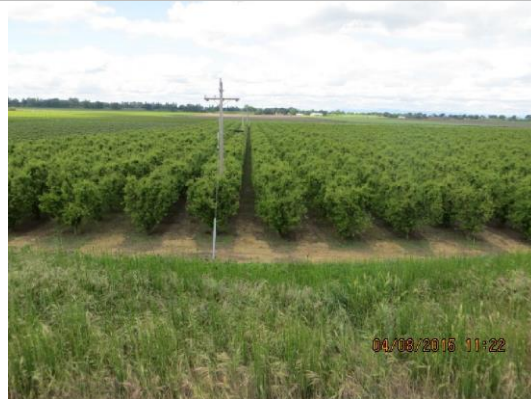
Photo 3 of 3 : UCIP_SP_2018_46172_74555.jpg

LM Start	3.15	Rating **	M	Issue No.	101 (cont)	
LM End	3.15	Issue Type +	En	Location *		
Category	Supplemental			GPS Latitude/Longitude		
				Start	End	
Item	DWR UCIP Field Study			38.265608 °	38.265608 °	
				-121.588391 °	-121.588391 °	
DWR ID						
Comment Code						
Inspector Comment						
FS_ID:46172						
DS_ID:25099						
EP_NO: N/A						
Repair Type: Non-Urgent						
Crossing Status: Found						
UCIP Comments: Appears abandoned and if so should be verified as having been done so properly.						
FIELD_STRUCT_DESC: *ABANDONED* 6-inch pipe of unknown material or purpose through the levee, 4.5 feet below the levee crown.						
Service pole at landside (LS) toe.						
FS Date: 4/2/2015

Approximate pipe alignment on LS.

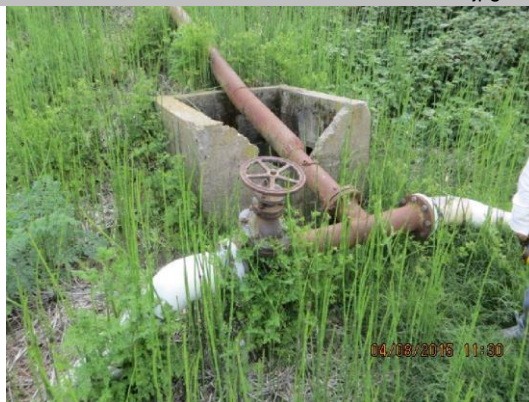
Photo 2 of 3 : UCIP_SP_2018_44333_73712.jpg

distribution box and pipe visible on LS toe.

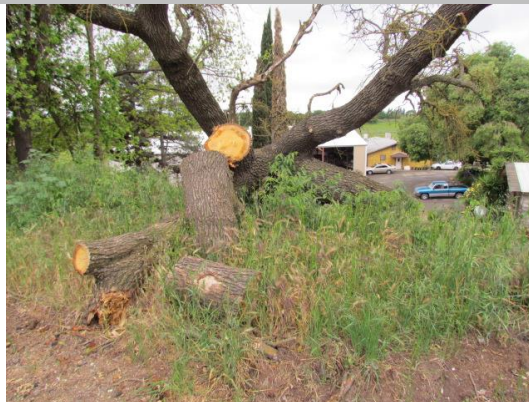
Photo 1 of 2 : SP_2018_RD0349_205_50_20180305_00044.jpg

LM Start	3.69	Rating **	M	Issue No.	50
LM End	3.69	Issue Type +	En	Location *	LS
Category	Earthen Levee			GPS Latitude/Longitude	
				Start	End
Item	Encroachments			38.261578 °	38.261578 °
				-121.594820 °	-121.594820 °
DWR ID	DWR_RD0349_02_f_2017_50				
Comment Code					
TR : Tree or limb					
Inspector Comment					
Remove the fallen tree from the levee slope and remove the cut up fire wood from the shoulder landward.

Landside slope levee mile 3.69.
